By Frank Immel

DRIVING SUCCESS WITH COOPERATION

Seattle, WA

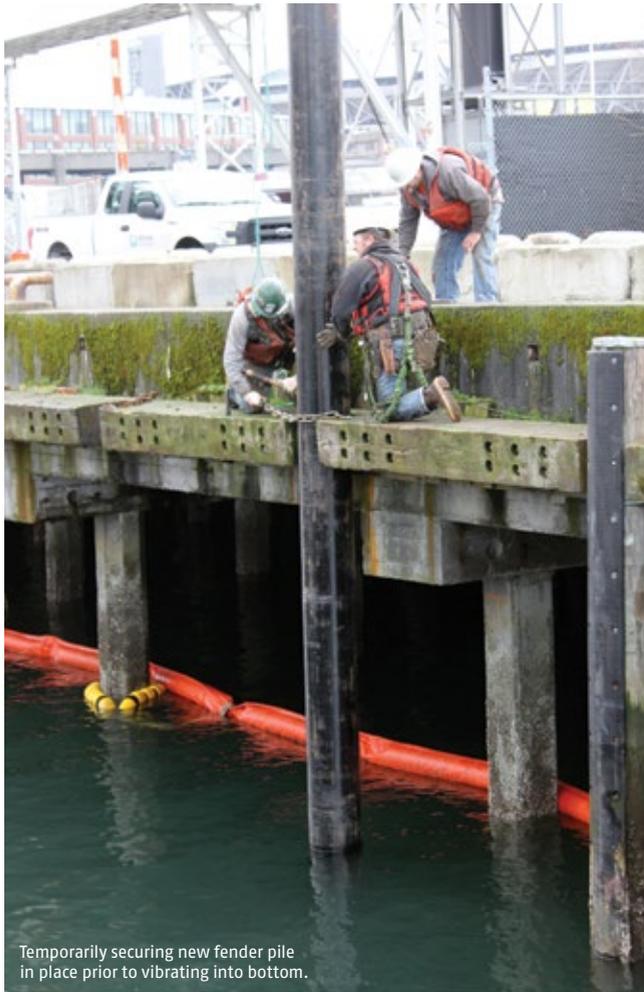
Temporarily securing new fender pile in place prior to vibrating into bottom.

New pilings, 80-foot lengths of steel pipe pile

were used for the new fender system. These pilings were driven with the vibratory hammer to -60 MLLW. Installation began on Feb. 4th and was completed by February 10th, four days ahead of the mandated fish closure window. The tops of the pilings were cut to the proper height, caps were welded on, and they were secured to the wooden fender railing by February 15th. Final inspection by the engineer of record, STP, Port of Seattle, and WSDOT was completed, and Global was off-site by February 16th.

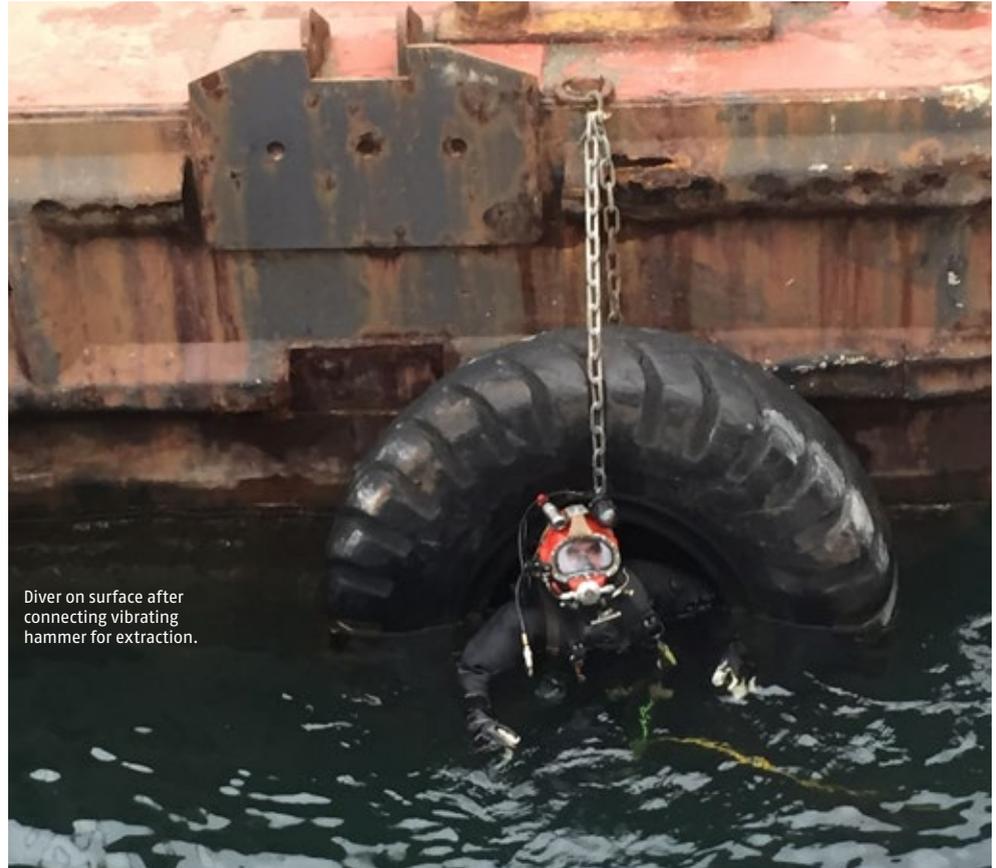
Diver on surface after connecting vibrating hammer for extraction.

personnel, and necessary material procurement were all completed within the next three days, and Orion Marine Contractors was subcontracted to provide derrick barge services. Once the broken pile stubs above the water were removed from the fender rail, Global divers attached the vibratory hammer to the remaining pile stubs and vibrated the

piles out of the bottom. All but three of the pilings were vibrated out — three were left because a section of the dock was blocked overhead by the barge-loading conveyor system. They would have to be cut off. Divers moved the bottom material from around them, uncovering just over two feet of each below the mud line. The stub was rigged to the crane, and divers, using a hydraulic chain saw, cut the piling off two feet below the natural bottom. The stubs were then removed from the water, and divers filled the holes back in. All of the piling remnants were removed from the water and disposed of properly.
